Structural Lesions Detected by Magnetic Resonance Imaging in the Spine of Patients with Spondyloarthritis – Definitions, Assessment System, and Reference Image Set

MIKKEL ØSTERGAARD, WALTER P. MAKSYMOWYCH, SUSANNE J. PEDERSEN, PRAVEENA CHIOUCHANWISAWAKIT, and ROBERT G.W. LAMBERT

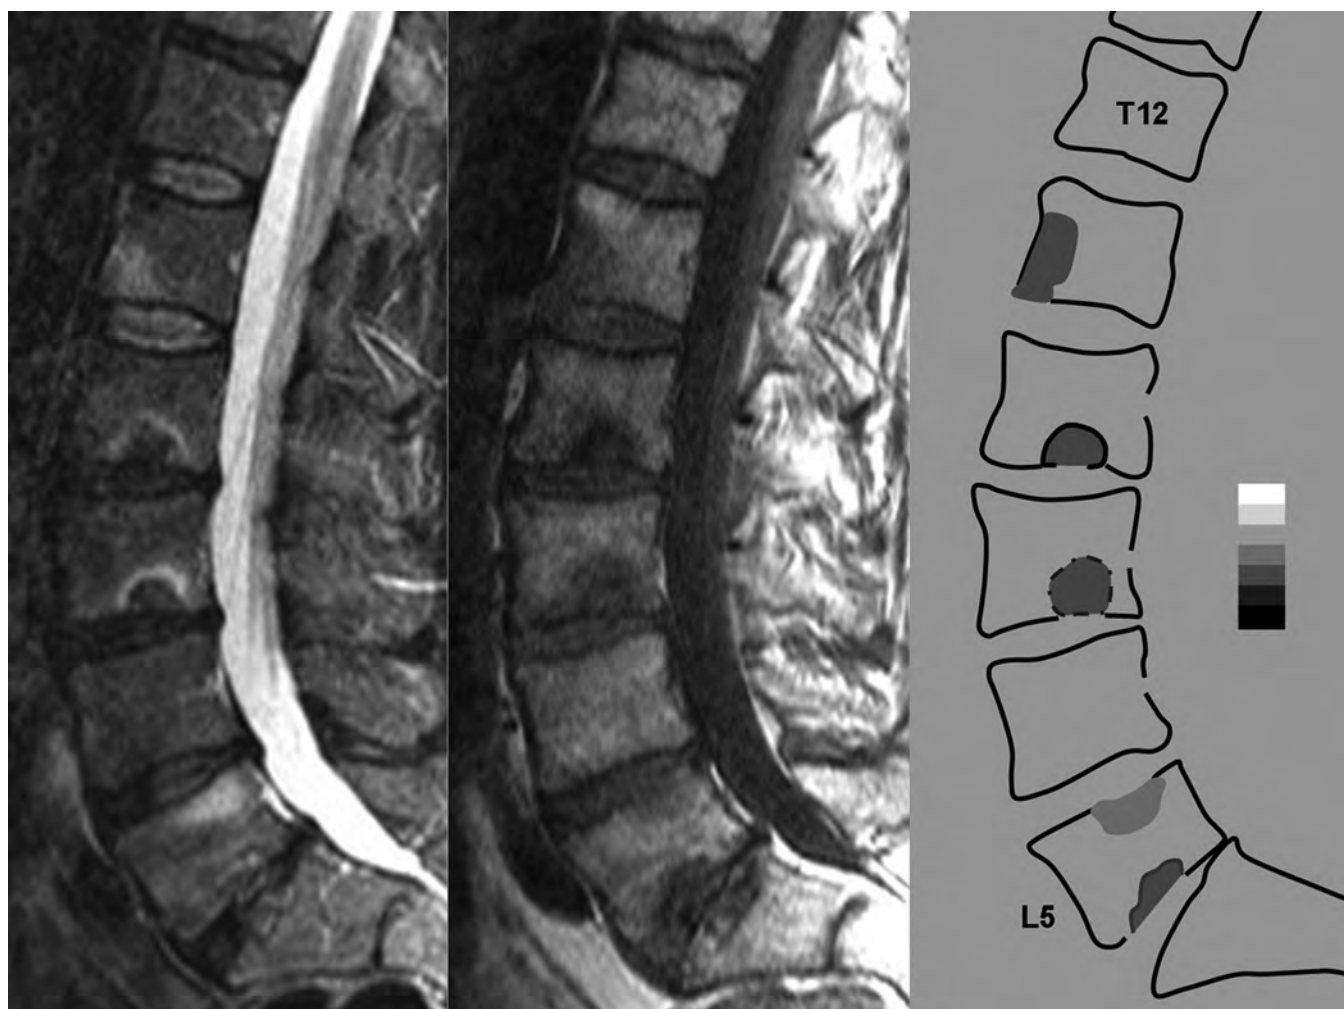
Figure 1. Corner bone erosion (COBE) and non-corner bone erosion (NOBE). An aCOBE is present at the L1 inferior endplate on the T1 image. The STIR image shows increased signal indicating active inflammation at this corner [anterior corner inflammatory lesion (aCIL)]. There is a large central Type A NOBE at the L2 inferior endplate [on the STIR image a non-corner inflammatory lesion (NIL) with a dimorphic appearance is seen]. A conspicuous area of marrow fat signal loss at the L3 inferior endplate is easily seen on the T1 image. However, at this level, the large central Type A NOBE is in fact at the threshold of detection because most of the cortex is intact on the T1w image. However, there is just enough

cortical destruction for this to be positive. A rim of active inflammation is identified on STIR (NIL, with dimorphic appearance). A large central Type B NOBE at the L5 superior endplate is also considered to be at the threshold of detection but for a quite different reason: although there is clear evidence of cortical destruction, the lesion is relatively subtle on the T1 image as bone marrow signal is only slightly reduced, whereas associated active inflammation on the STIR image is easily seen. Note that the apparent presence of a cortex on the STIR image is in part related to intact hyaline cartilage of the endplate rather than intact cortical bone. At the L5 inferior endplate, there is a large central Type B NOBE.

A1. Corner bone erosion (COBE) is defined as a bone erosion involving the vertebral corner, in at least one central sagittal slice, with an anterior COBE (aCOBE) being a COBE at the anterior corner (Figures 1, 2, and 4) and a posterior COBE (pCOBE) being a COBE at the posterior corner (Figures 3 and 4). aCOBE and pCOBE may be further categorized as “large” if a lesion extends to more than 25% of the anteroposterior (AP) diameter of the original endplate and/or of the original height of the vertebra, in any sagittal slice (Figures 1 and 7).

A2. Non-corner bone erosion (NOBE) is defined as a bone erosion adjacent to the vertebral endplate on any slice and not involving the vertebral corner on any central sagittal slice. A NOBE may be further categorized as “central” if it involves any central sagittal slice (Figures 1, 4, and 9) or as “lateral” if it involves any lateral sagittal slice (Figure 8). Note that the same NOBE can be both central and lateral if present in both central and lateral sagittal slices. A central NOBE may also be further categorized as “large,” if it involves more than 25% of AP diameter of the original endplate and more than 25% of the original height of the vertebra (Figure 1). Finally, a NOBE is further categorized as “Type A” or “Type B,” depending on whether the diameter of neck (at the cortical break) is less (Type A) or at least equal to (Type B) the maximal diameter of the loss of the high signal in the bone marrow (Figure 1).

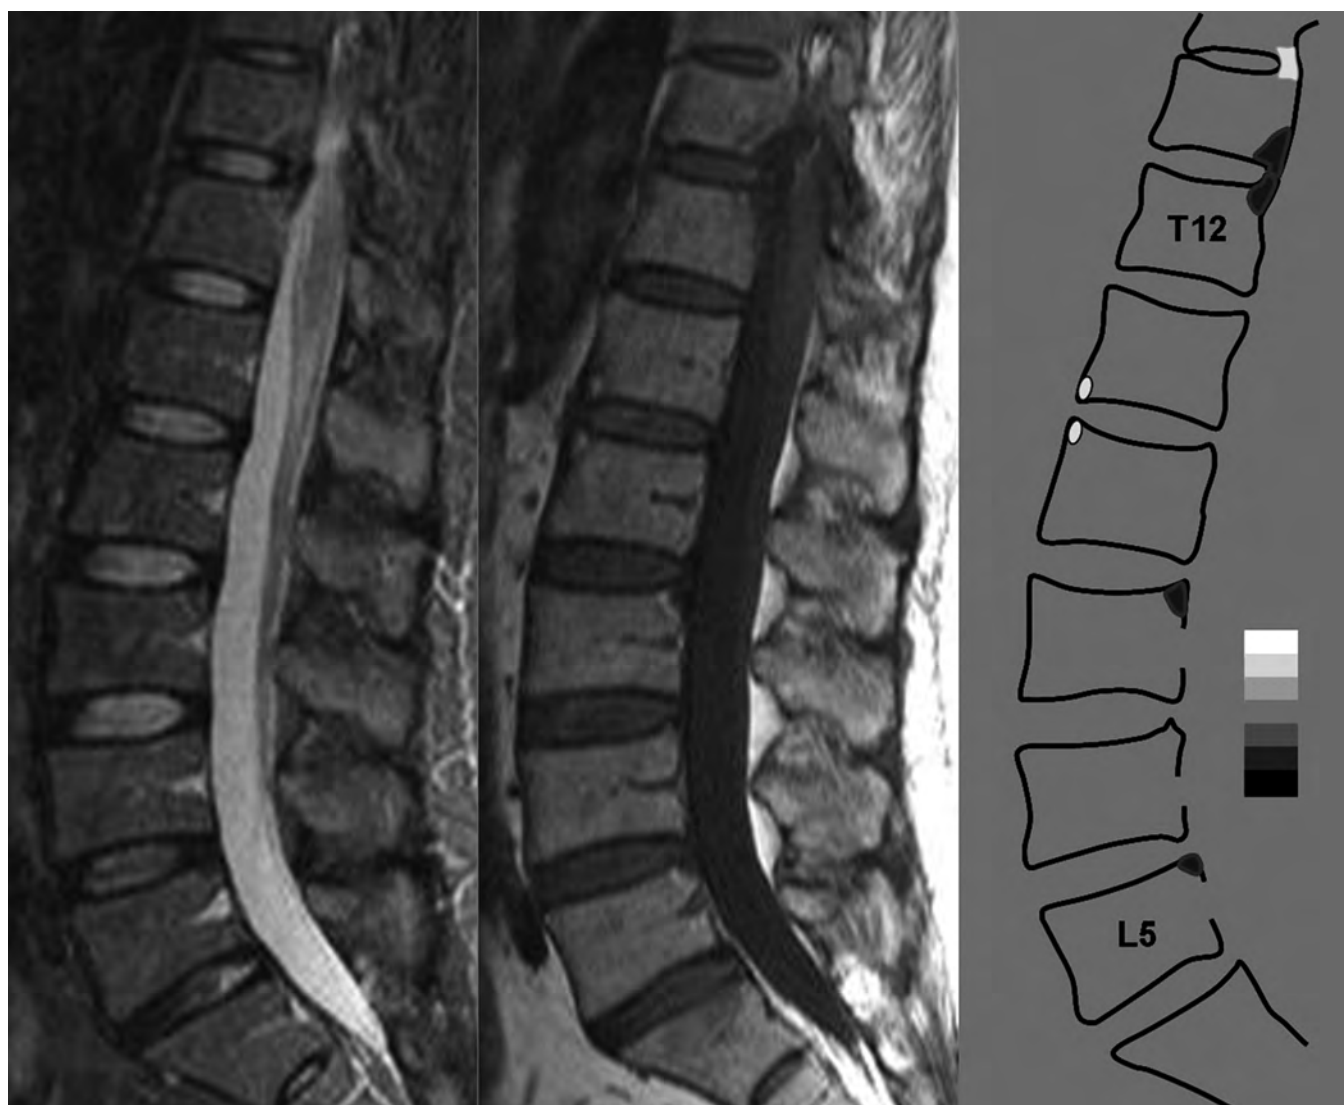
Figure 3. Corner bone erosion (COBE) and non-corner ankylosis (NANK). A posterior corner bone erosion (pCOBE) is present at the L5 superior endplate. However, some chronic lesions are very difficult to ascertain and classify. In this case, 3 areas of abnormality are seen posteriorly at the corners of the T11 inferior, T12 superior, and L3 superior endplates. The cortices appear to be intact or at least not clearly eroded. The bone marrow signal is reduced, likely due to fibrosis and/or sclerosis, and these may be the MRI equivalent of the well known radiographic sign, “the shiny corner.” Unfortunately, it is

rarely possible to be certain that this truly represents sclerosis, and bridging compact bone cannot be distinguished from the normal fibrous tissue of the annulus fibrosus or longitudinal ligament. Some corner fat can be seen, but subtle bony prominence at some corners is below the threshold for a corner spur, except at L4 superiorly where a tiny spur is present at the posterior corner. Posterior ankylosis at T10/11 is present on a lateral slice at this level (lateral NANK) and is easier to see because of the bright fat signal in the bridging spur.

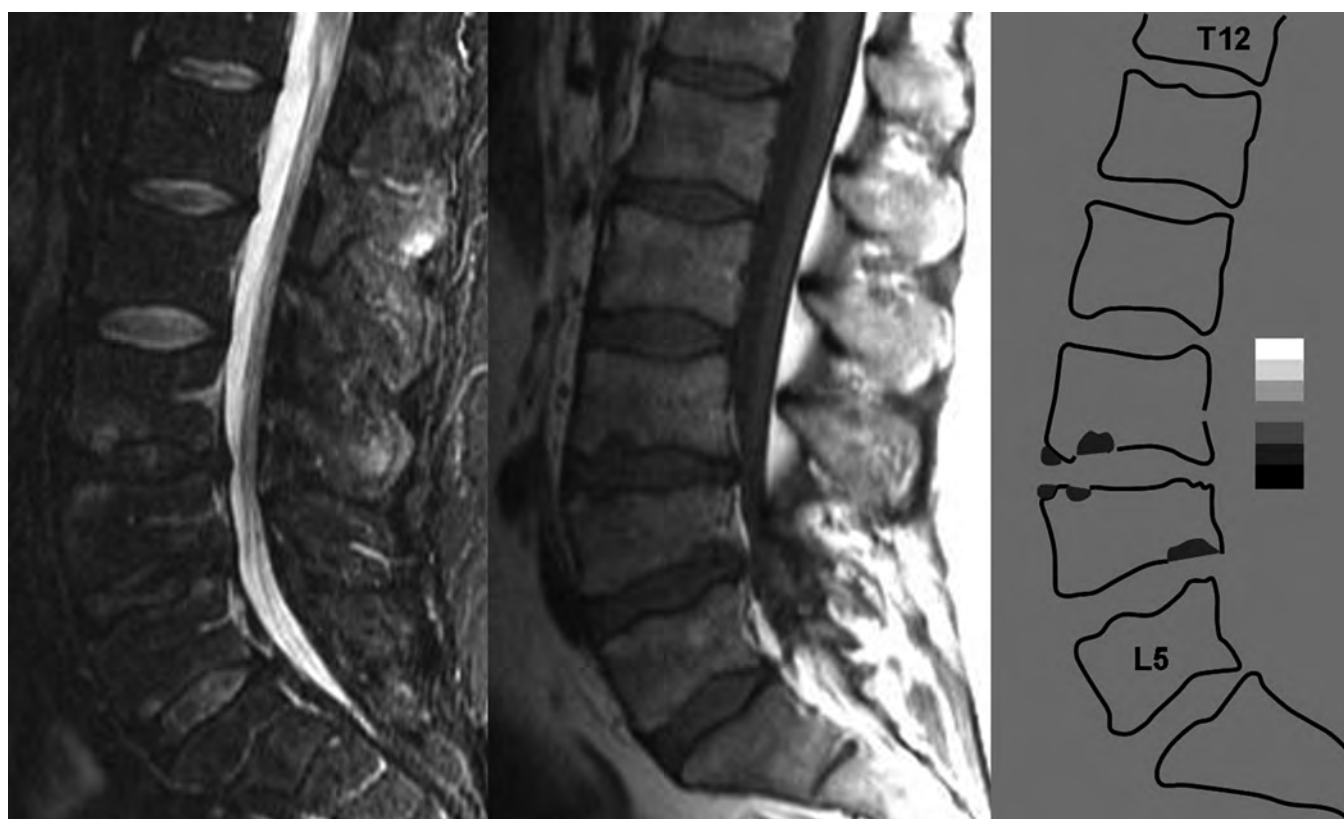
Figure 4. Corner (COBE) and non-corner bone erosion (NOBE). Small erosions are difficult to discern in many instances. In this case non-corner bone erosions (NOBE) are seen on either side of the L3/4 intervertebral disc. However, subtle deformities of the anterior corners of these 2 endplates are consistent with tiny corner bone erosions (aCOBE) at the threshold for detection. The difficulty for the reader is 2-fold: (1) Does the subtle defor-

mity of the corner represent anatomical variation or erosion of the original corner with sclerosis at the edge of the erosion? (2) If erosion is present, is it continuous with the NOBEs? A more obvious erosion is present posteriorly at the L4 inferior endplate (pCOBE). Slight irregularities of other vertebral corners do not constitute detectable lesions.

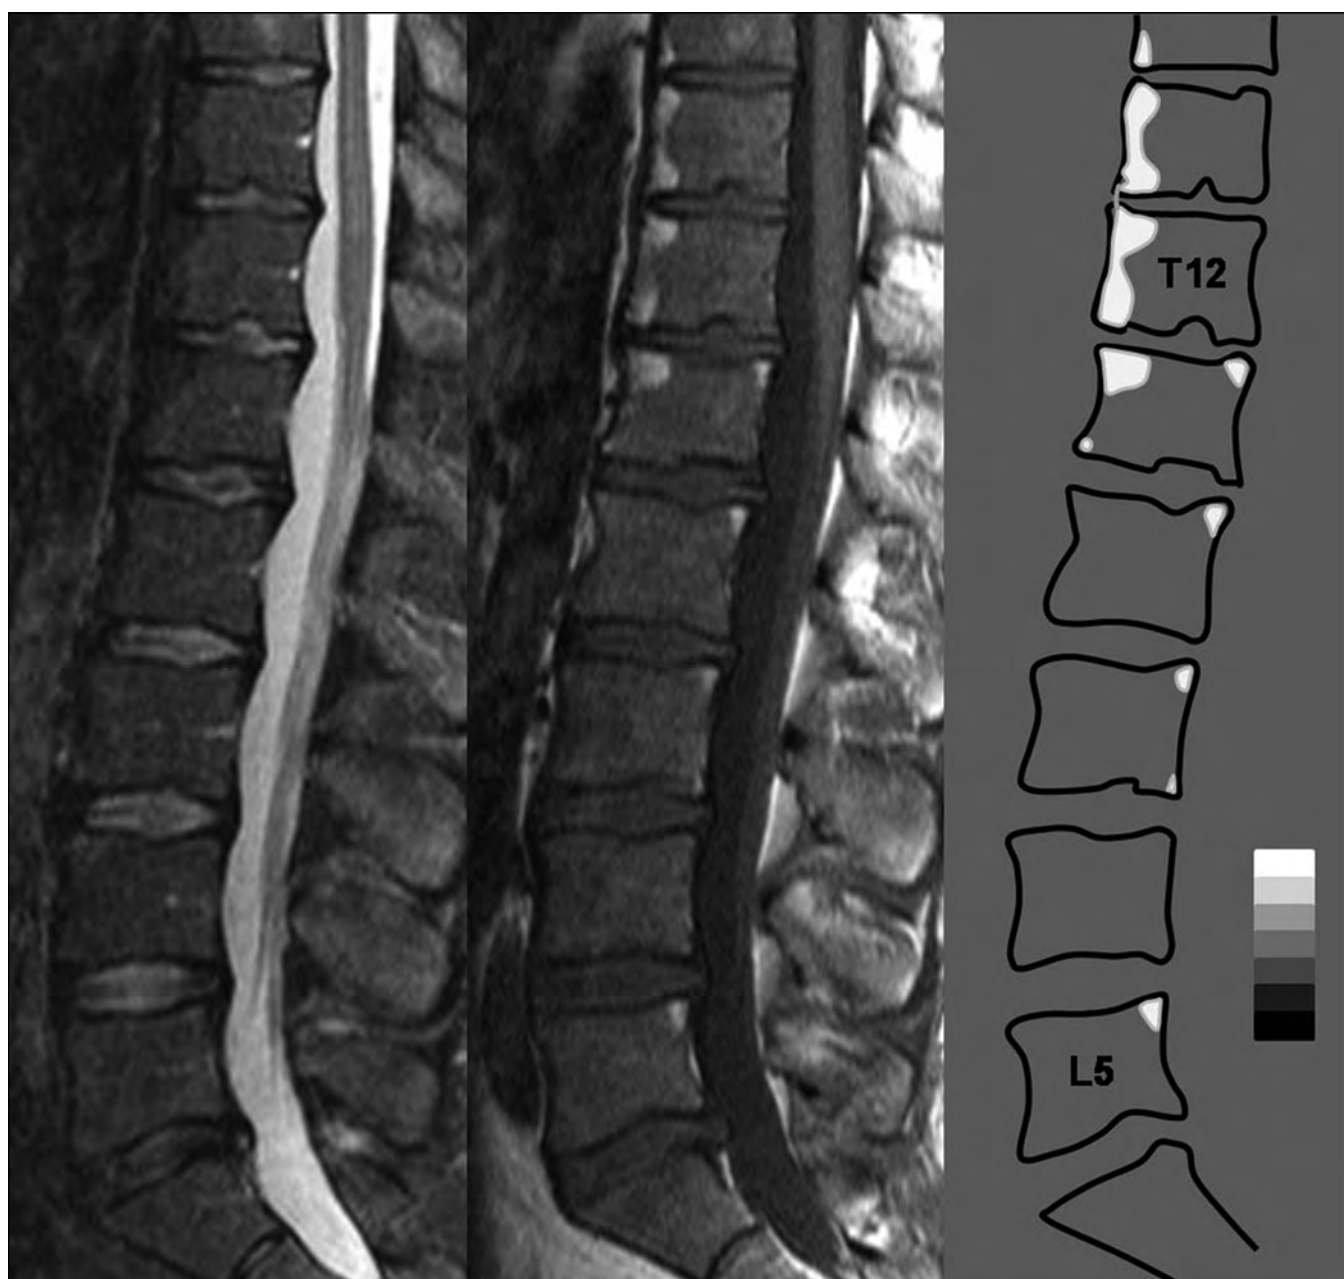
Figure 5. Focal fat infiltration at vertebral corners (aFAT, pFAT) and vertebral corner ankylosis (CANK). Multiple foci of fatty infiltration of bone marrow are present at many vertebral body corners, anteriorly and posteriorly. The aFAT lesion at the L1 inferior endplate and the pFAT lesion at the L3 inferior endplate are at the threshold of detection. But faint increased signal at the anterior

corners of the L2 and L3 superior endplates are below threshold for detection. At T11/12 there is subtle anterior ankylosis (aCANK) with bright signal in bridging bony spurs at the threshold for detection. Normal irregularity of vertebral endplates with normal bone marrow does not meet the definition of a NOBE at any level.

B. Focal fat infiltration. Focal fat infiltration is defined as focal increased signal in bone marrow on T1w images. Only fat infiltration involving the vertebral corners on any central sagittal slice (corner fat infiltration) is assessed. By location these lesions are subdivided into anterior corner fat infiltration (aFAT), which is FAT at the anterior corner (Figures 5 and 9), and posterior corner fat infiltration (pFAT), which is FAT at the posterior corner (Figures 5 and 9).

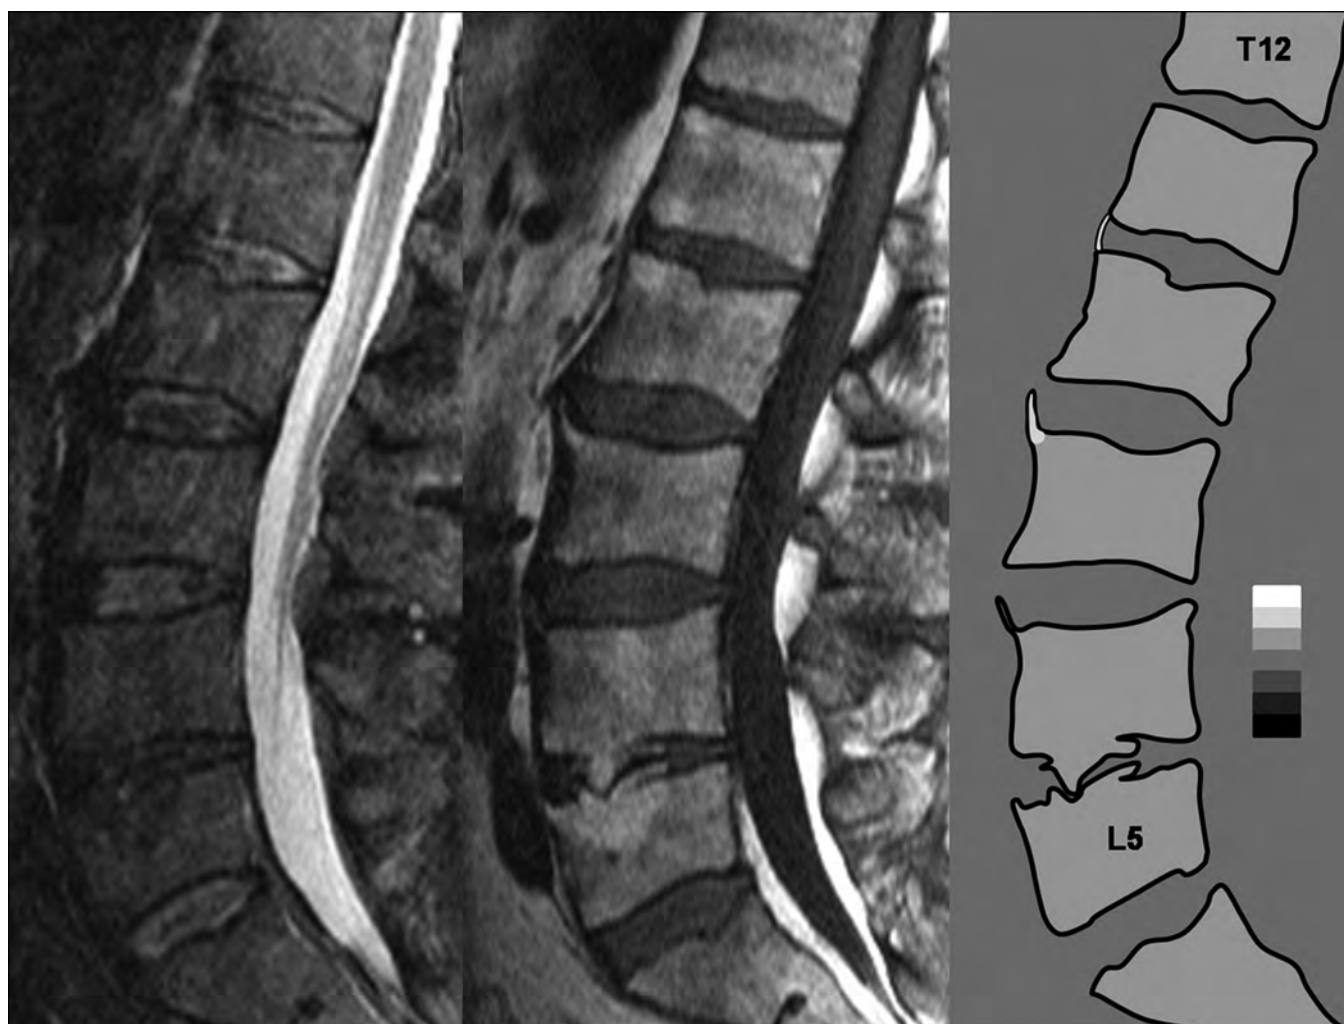
Figure 6. Vertebral corner spur (COS), non-corner spur (NOS), and vertebral corner ankylosis (CANK). Multiple bony spurs are present with varying configuration. At L1/2 there is anterior corner ankylosis (aCANK) at the threshold of detection. At L2 inferior, there is anterior bony irregularity that is below the threshold for detection of a spur. At L3 superior there is an anterior corner spur (aCOS) that is large and easily seen. At L3 inferior there

is anterior bony irregularity that is below the threshold for detection of a spur. At L4 superior, there is an anterior corner spur (aCOS) at the threshold of detection. At L4 inferior there is a large central non-corner spur (NOS). At L5 superior there is a large central non-corner spur (NOS), which is discontinuous with an anterior corner spur (aCOS) at the threshold of detection.

C1. Corner spur (COS) is a bone spur involving the vertebral corner, in at least one central sagittal slice, and can be either an anterior COS (aCOS; Figures 6 and 7) or a posterior COS (pCOS; Figure 7).

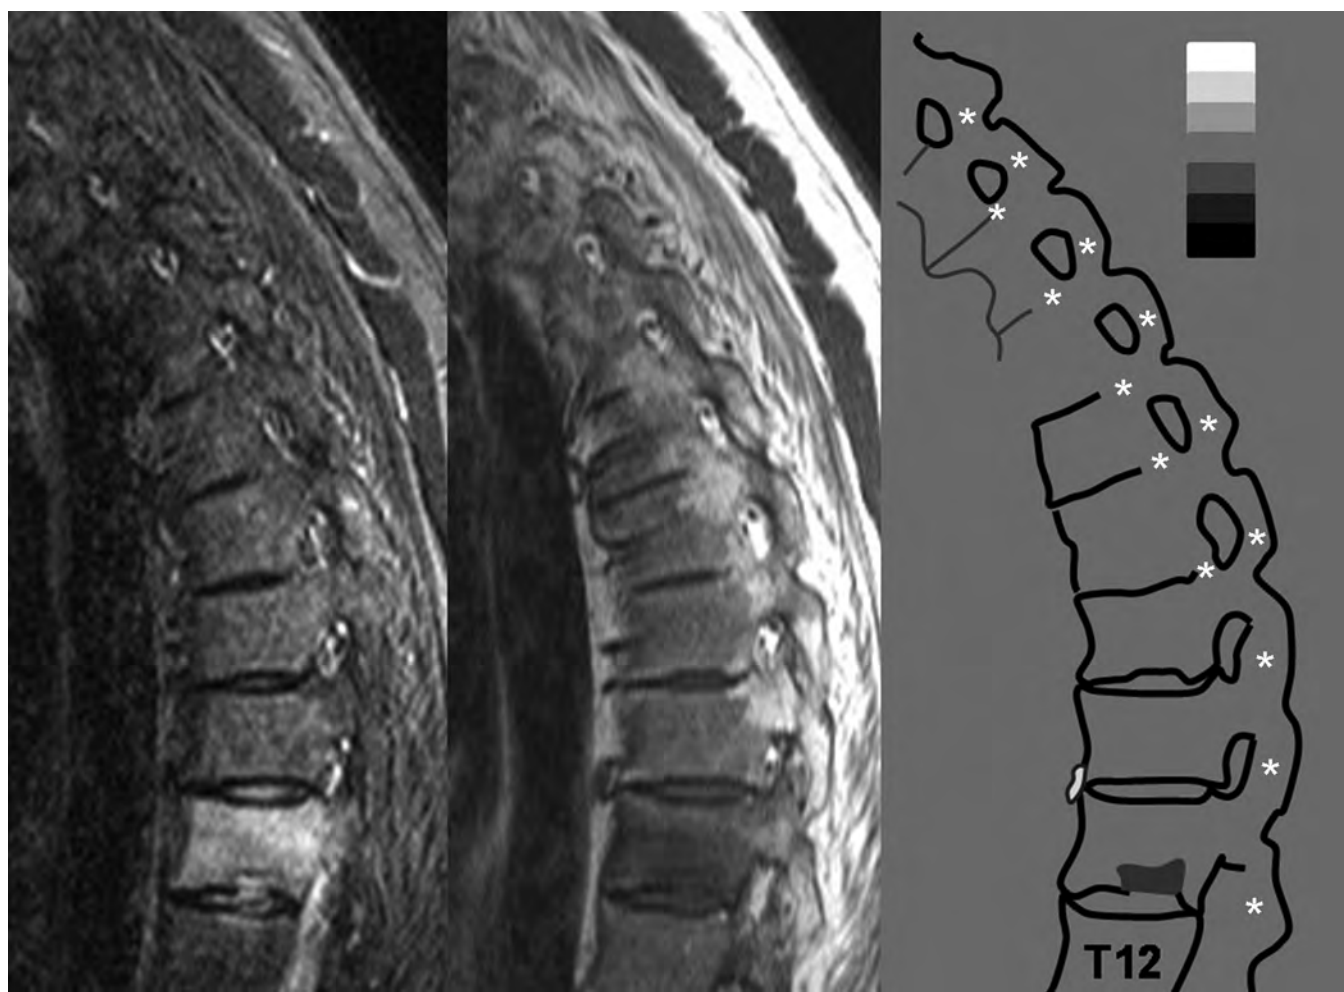
Figure 8. Lateral non-corner spur (NOS) and ankylosis (NANK) and facet joint ankylosis (FANK). A lateral slice of the thoracic spine demonstrates extensive ankylosis at all levels. Ankylosis is most pronounced in the facet joints (FANK) and in costovertebral joints posterolaterally in the vertebral body (lateral NANK). Subtle spurs and/or ankylosis can also be seen at some levels anteriorly

classified as non-corner spur (lateral NOS) and non-corner ankylosis (lateral NANK), respectively. Despite complete ankylosis of the spine (confirmed radiographically), the patient has active spondylodiscitis at T11/12 with a non-corner bone erosion (lateral NOBE) in the T11 inferior endplate and a “massive inflammatory lesion” (MIL).

D3. Facet joint ankylosis (FANK) is ankylosis of a facet joint. (Figure 8).

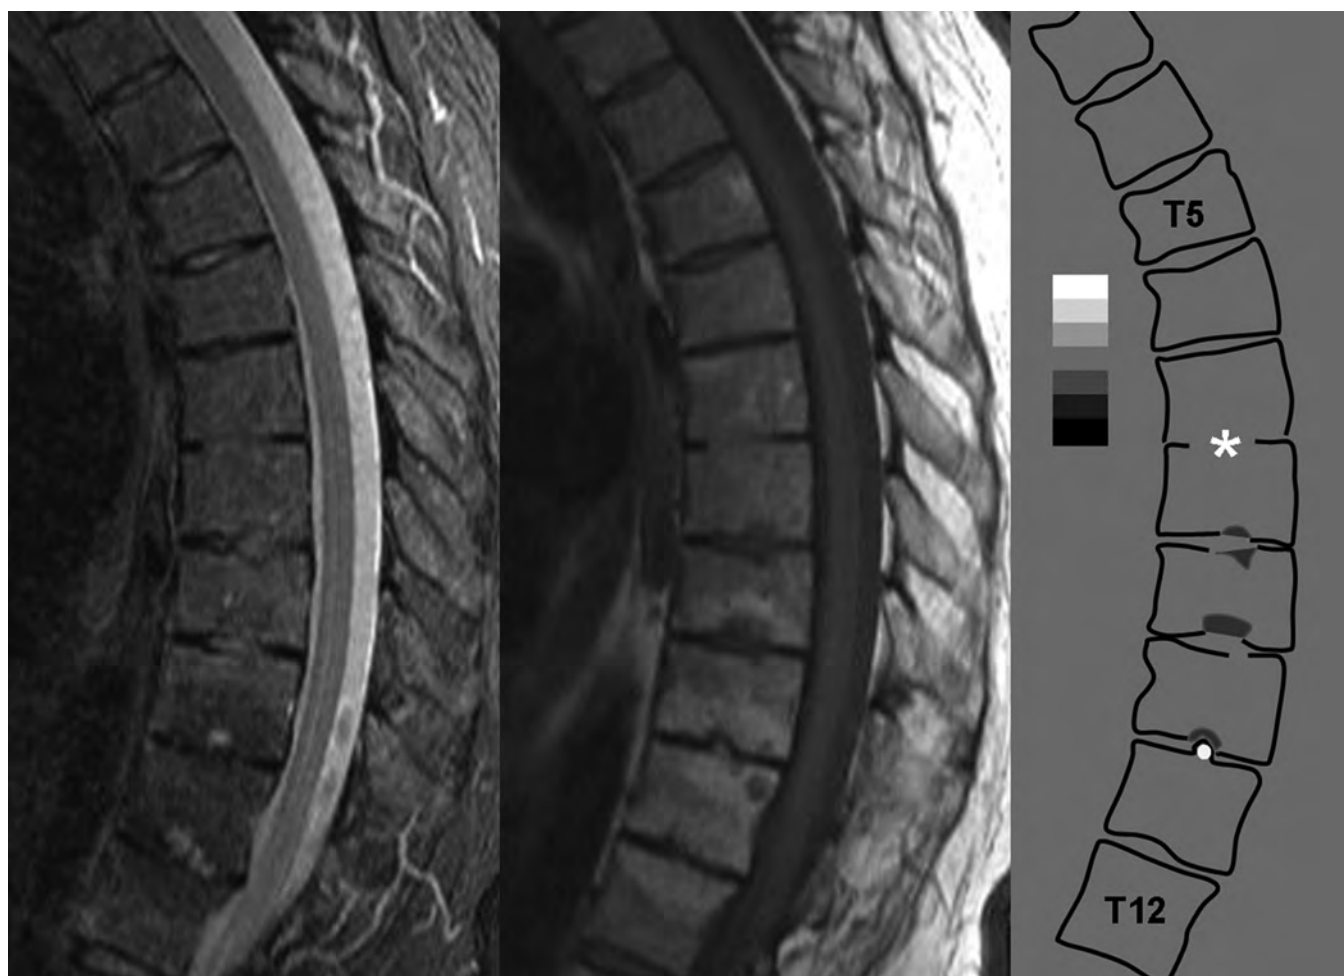
Figure 9. Central non-corner ankylosis (NANK), spur (NOS), and erosion (NOBE), and focal fat infiltration (aFAT and pFAT). Ankylosis in the thoracic spine is visualized at only one level. Complete ankylosis has developed across the T7/8 intervertebral disc. This is a central non-corner ankylosis (NANK). Erosion of the vertebral endplates is also present at other levels without involvement of the vertebral body corners (non-corner bone erosion; NOBE). Some of these are at the threshold

of detection, and a tiny irregularity at the superior endplate of T10 is below the threshold. A non-corner spur (NOS) is seen extending superiorly from the T11 superior endplate incorporating continuity of bone marrow signal with the vertebral body. There is also extensive fatty infiltration at multiple levels extending to the anterior and posterior corners (aFAT and pFAT), prominent at T9, T10, T11 and T12.
